**MAP ACTION**

**Country: Dominica**  
**Emergency: Hurricane Maria**  
**Aerial Reconnaissance of South and South-East**

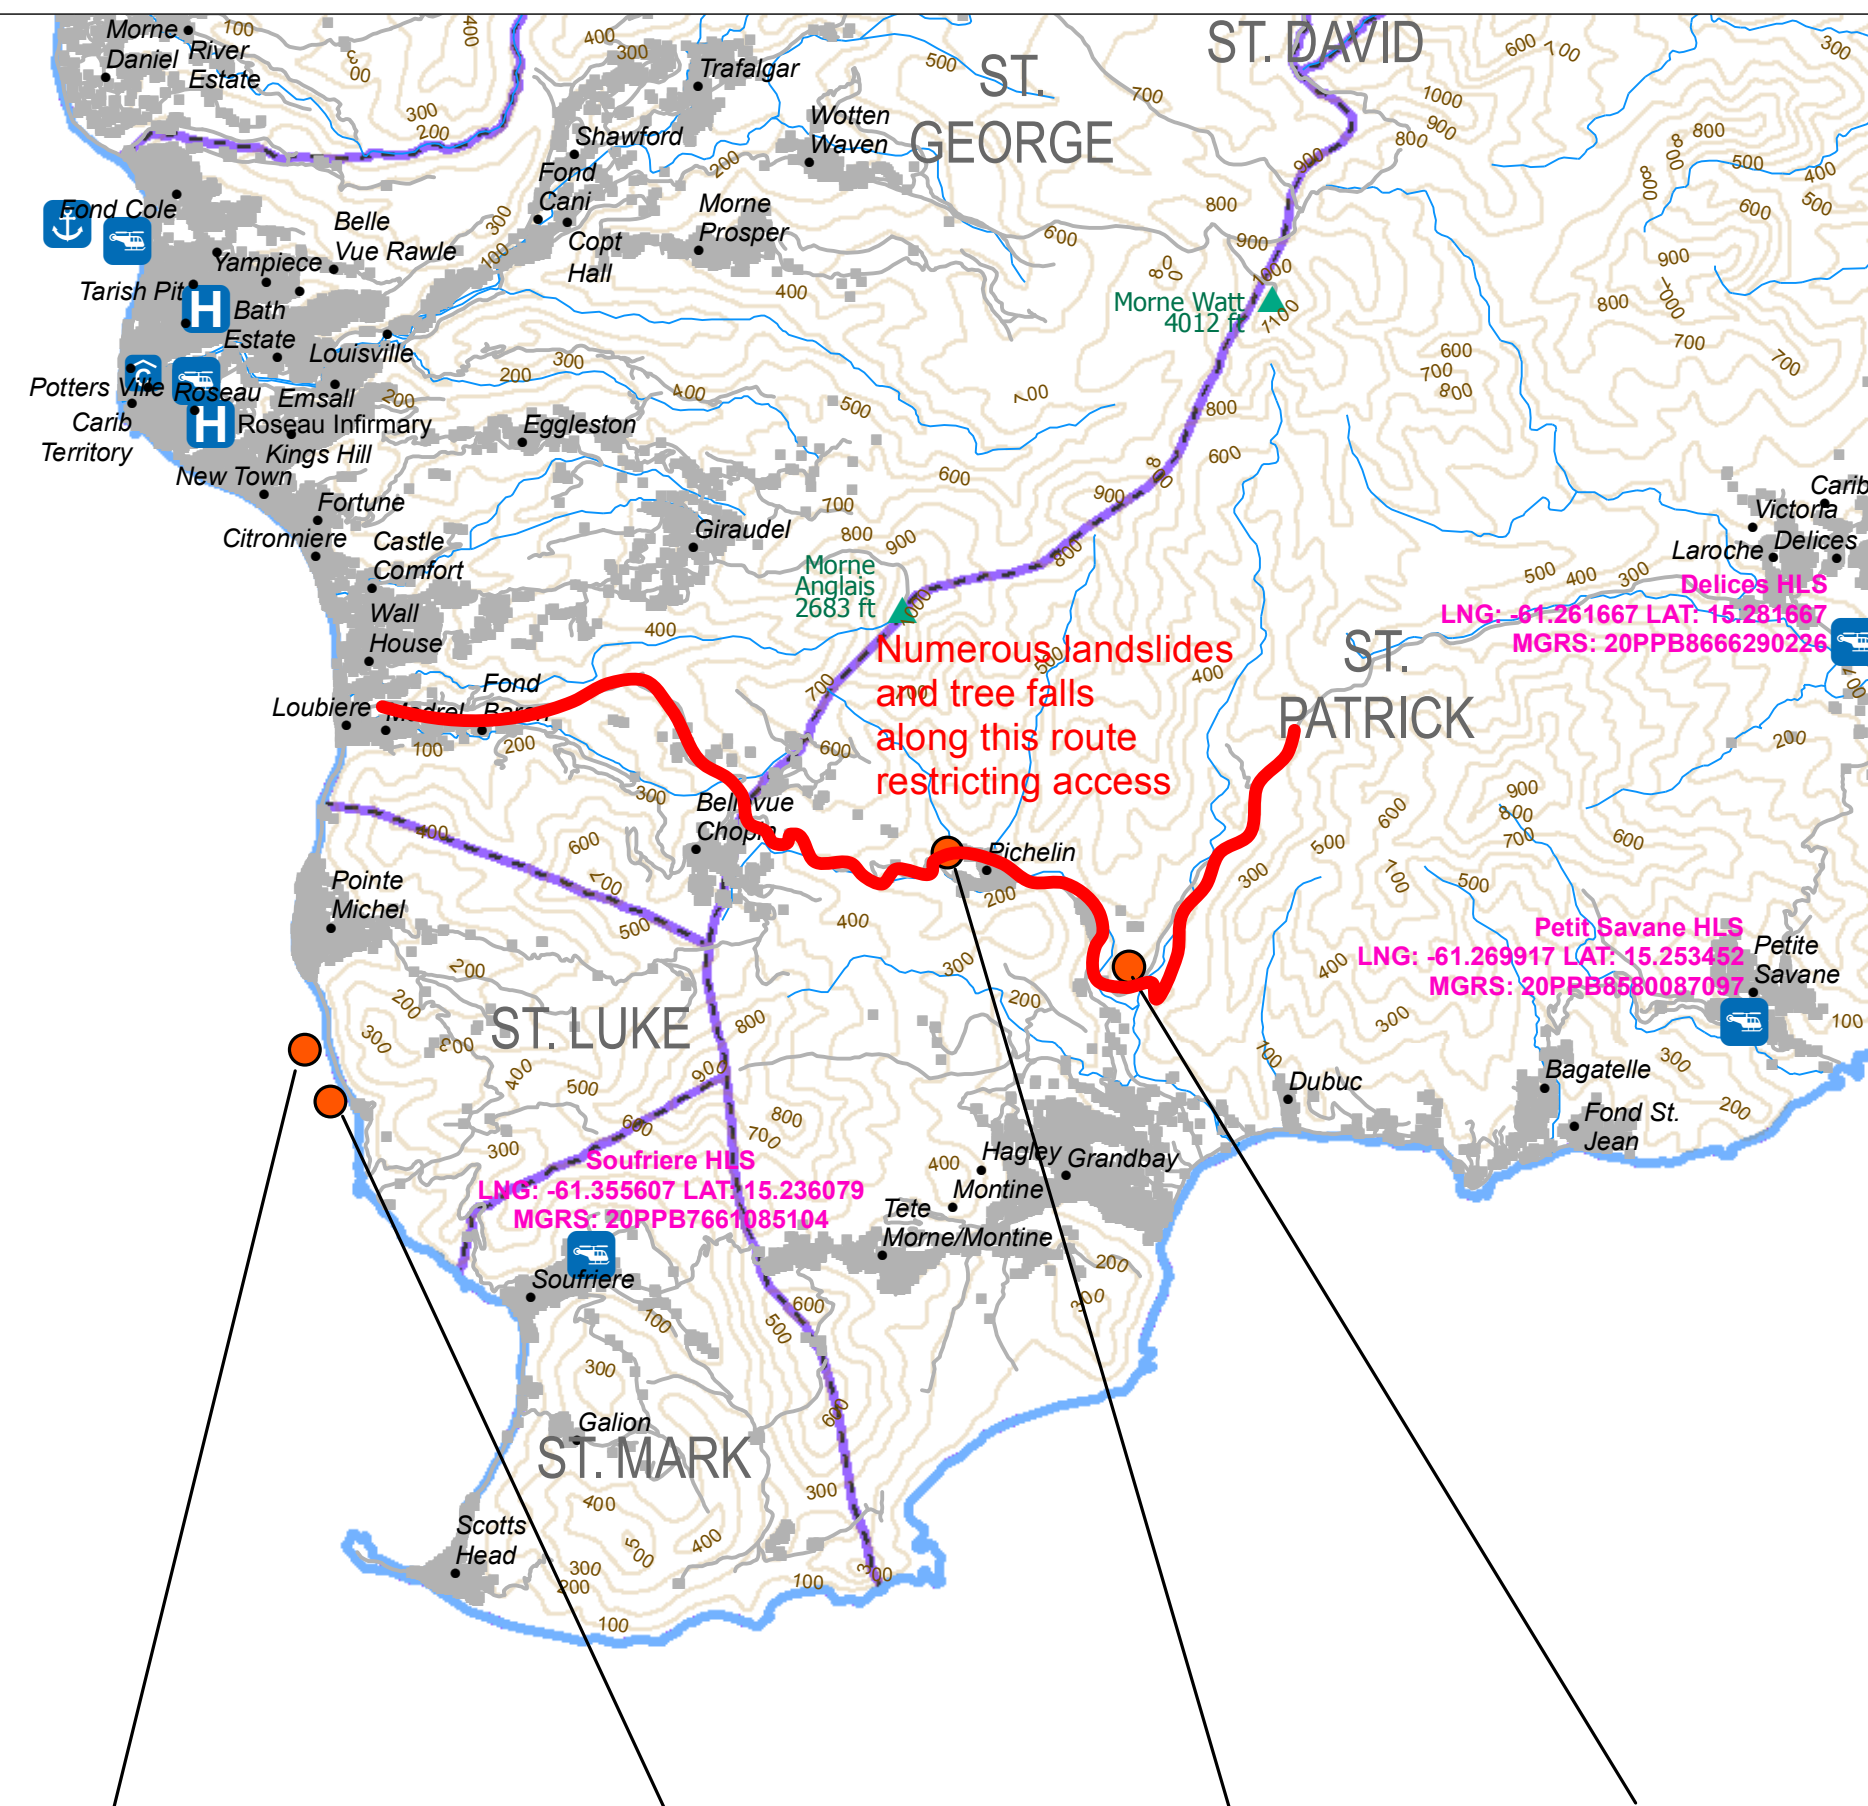
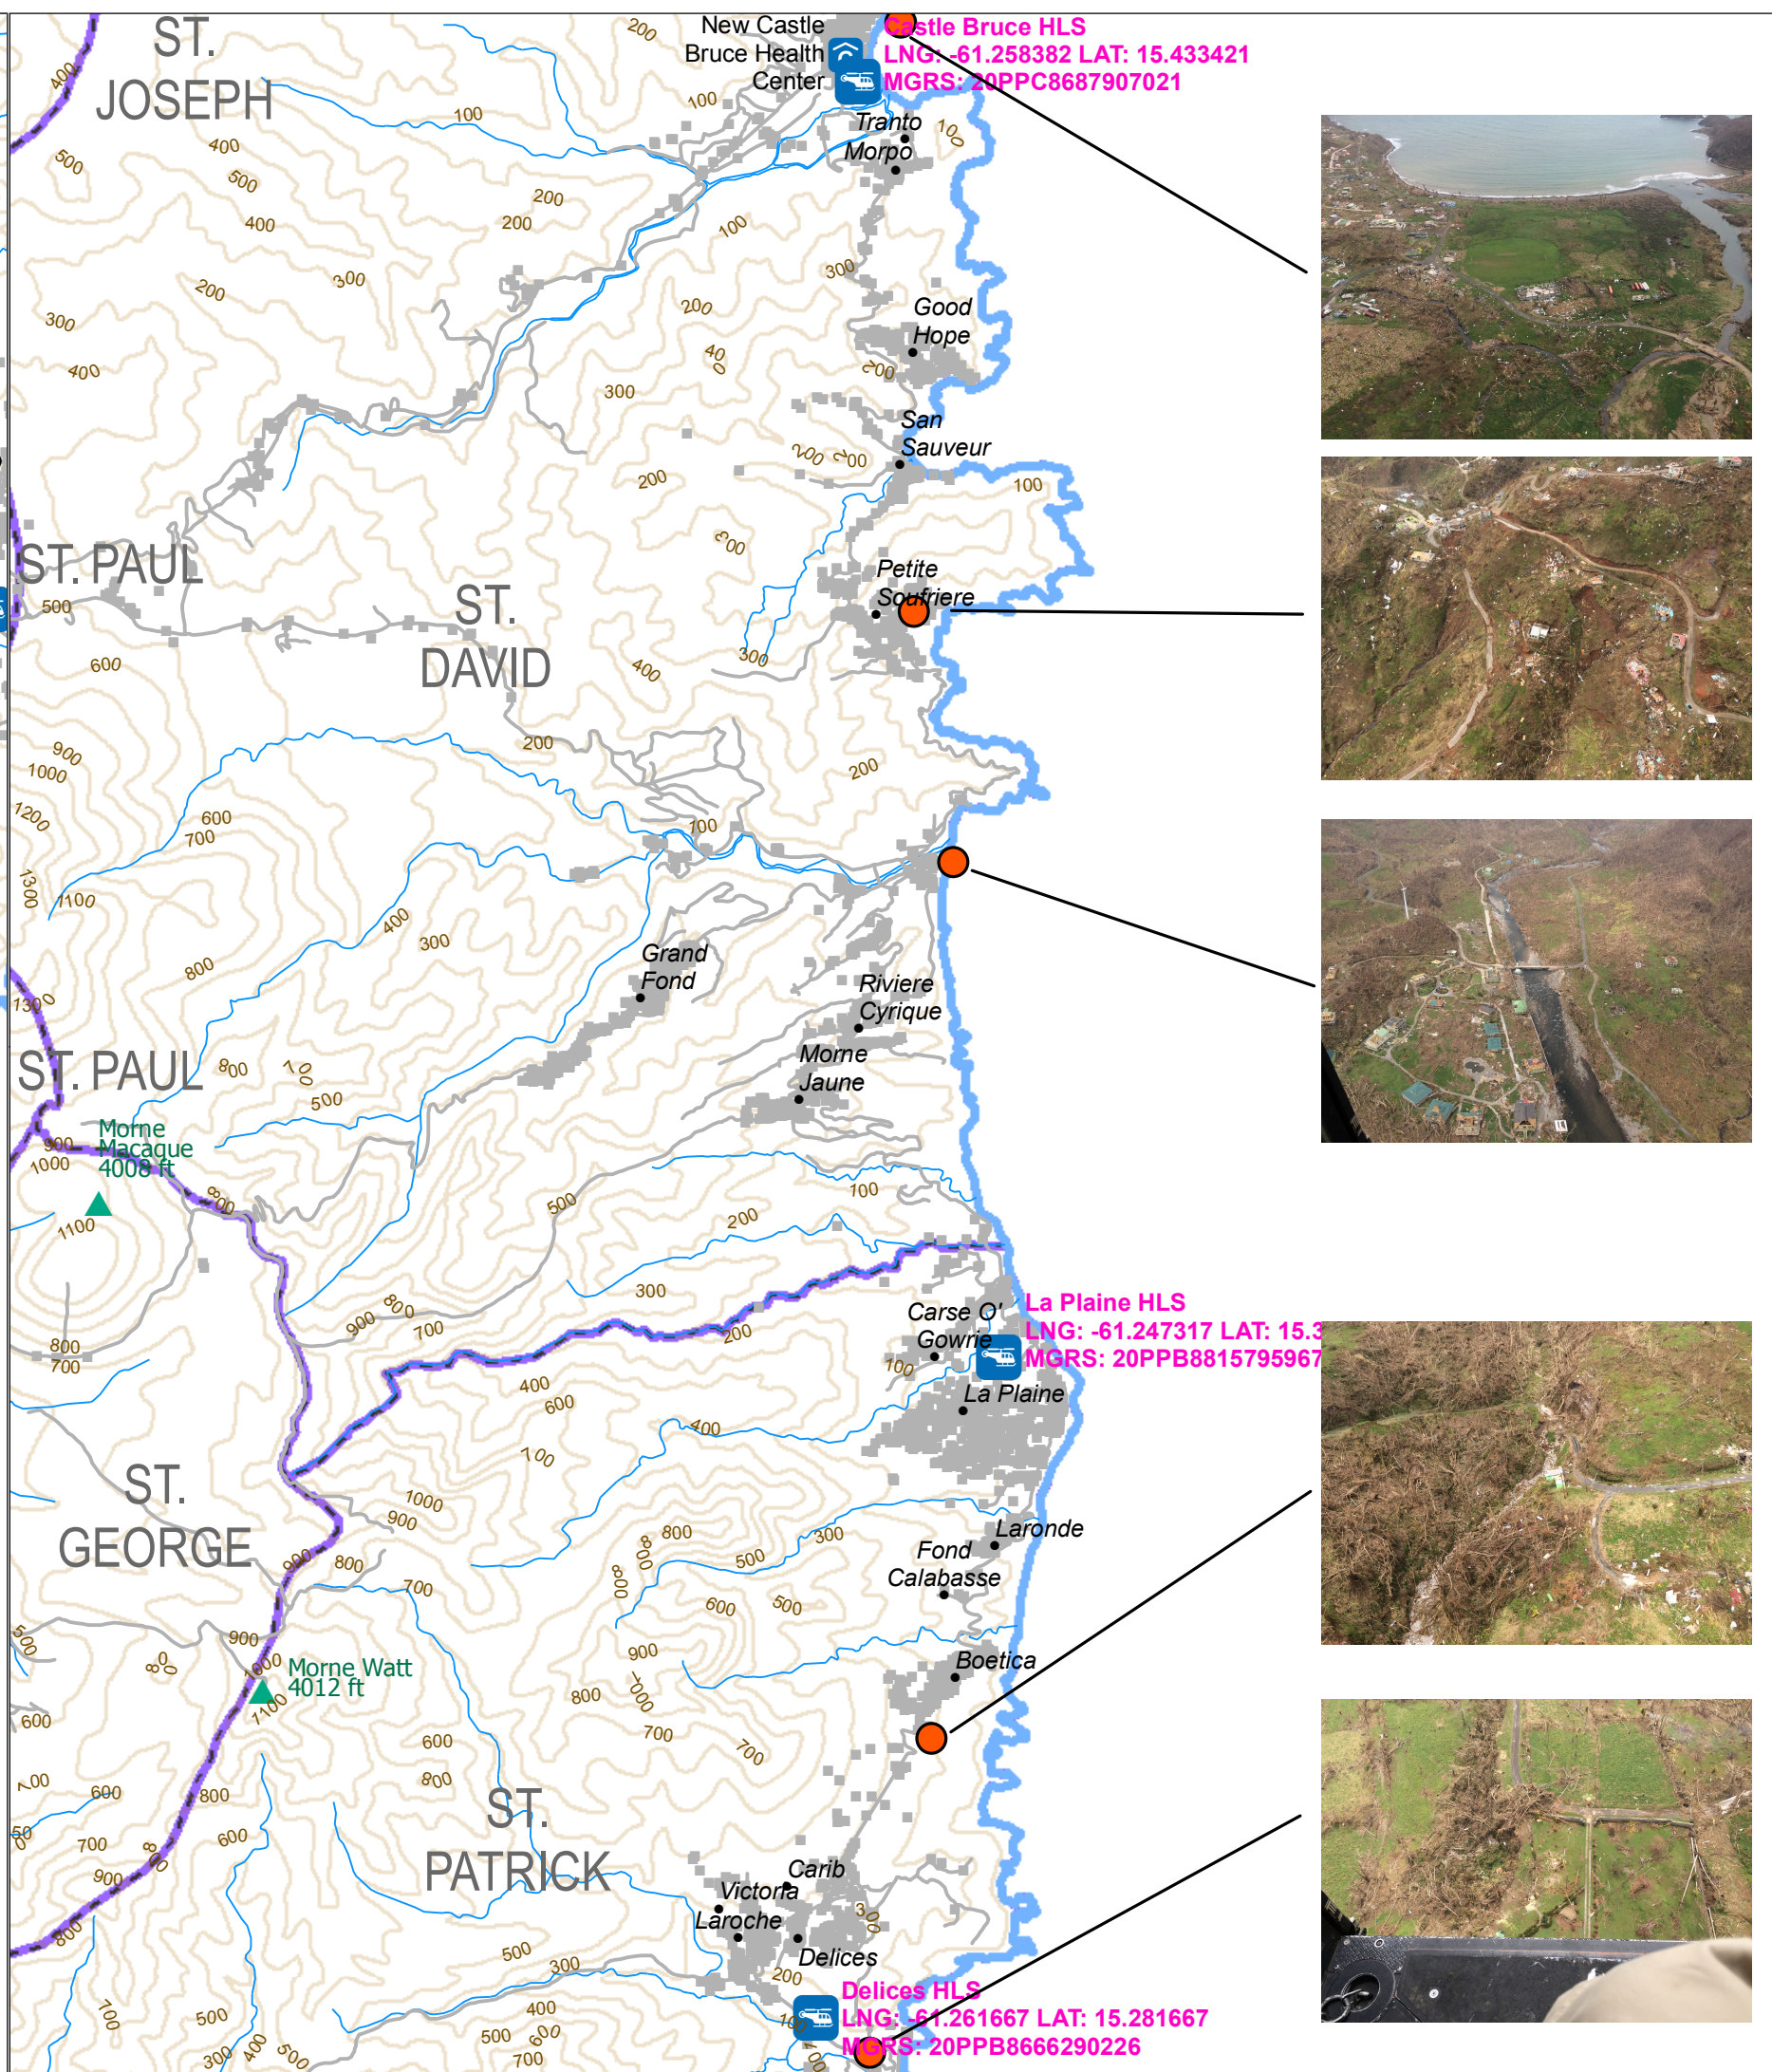
Aerial reconnaissance of the South and South-East of Dominica showing access restrictions and helicopter landing sites. The east coast and south west coast roads are blocked by landslides and tree falls. There are multiple landslides and blocks in the valleys surrounding Roseau. The road is blocked in multiple places between Loubiere and Pichelin.
